RSS Overhaul: P. Kiedron and J. Berndt

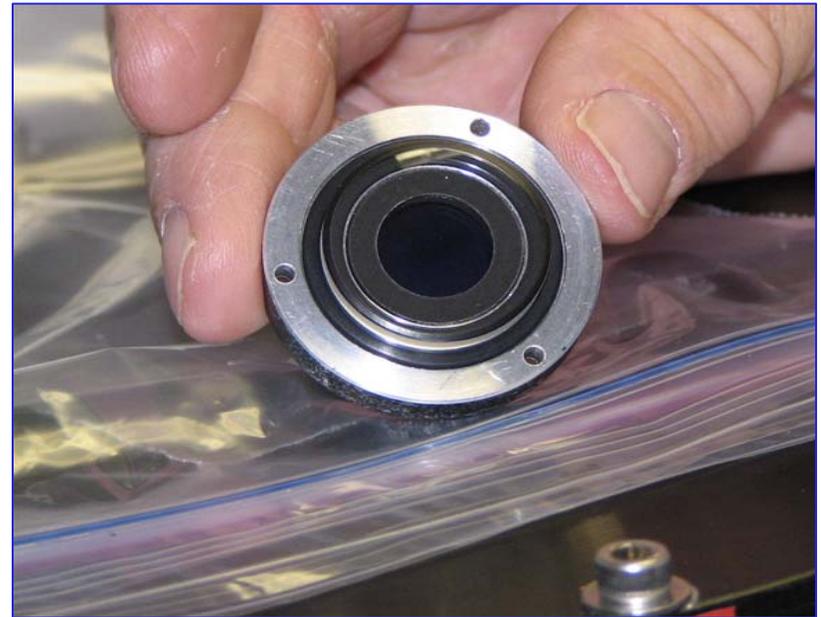
Shutter Replacement

Need of larger opening

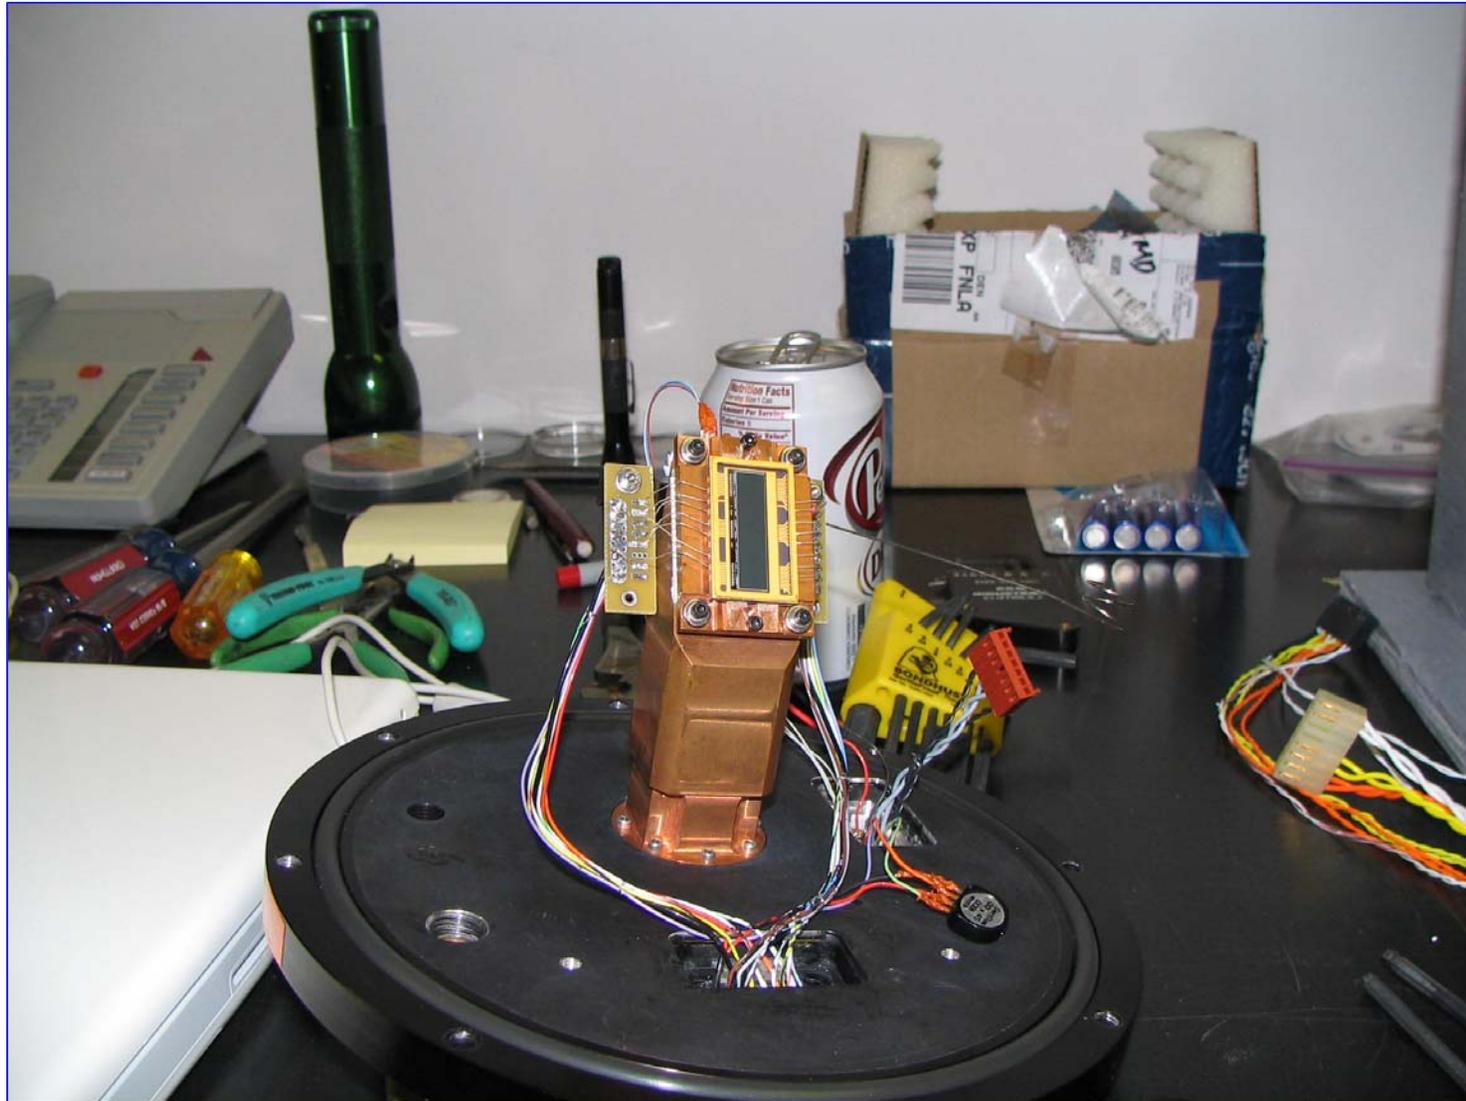
Deposits on CCD

Oily substance

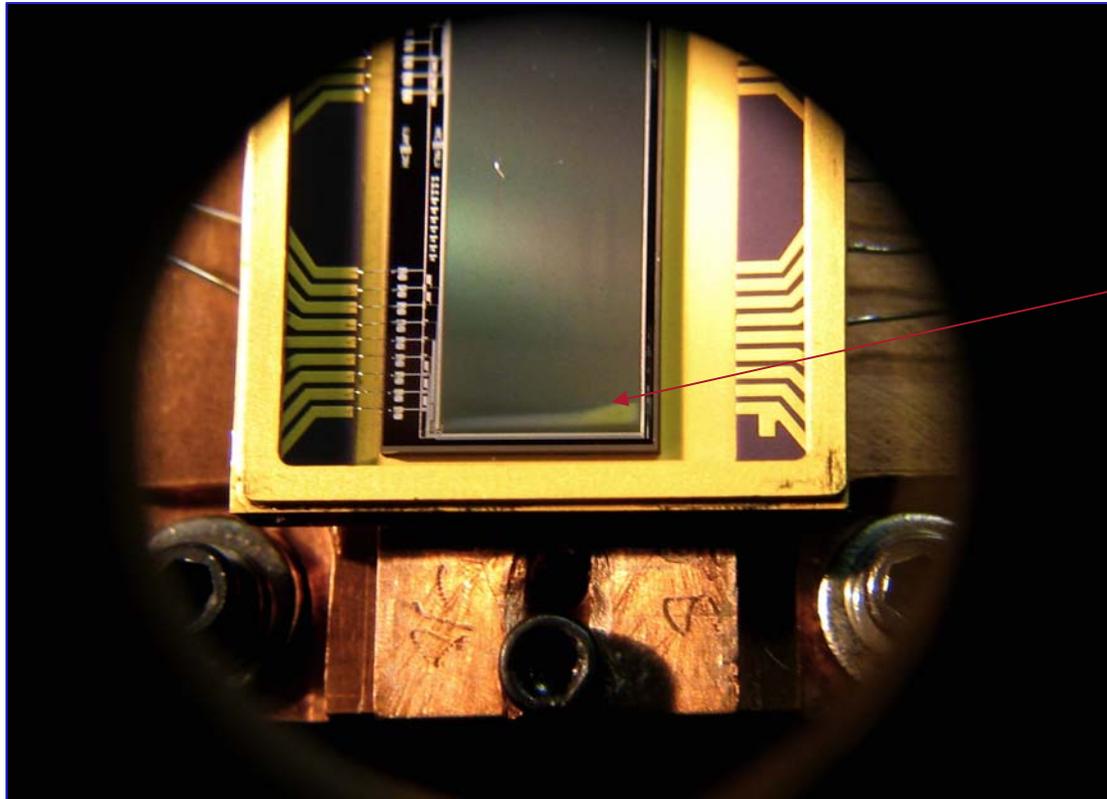
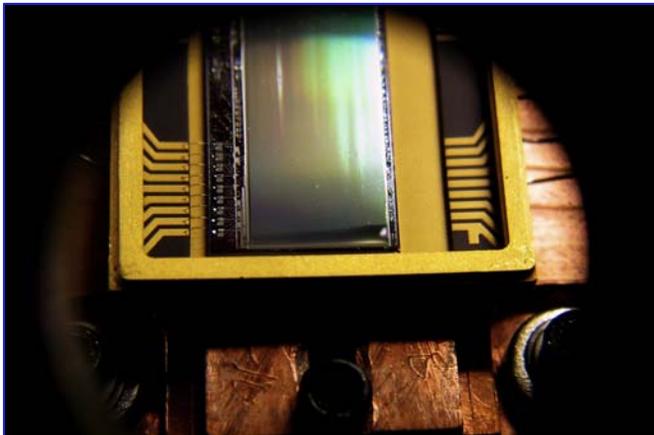
Smudges

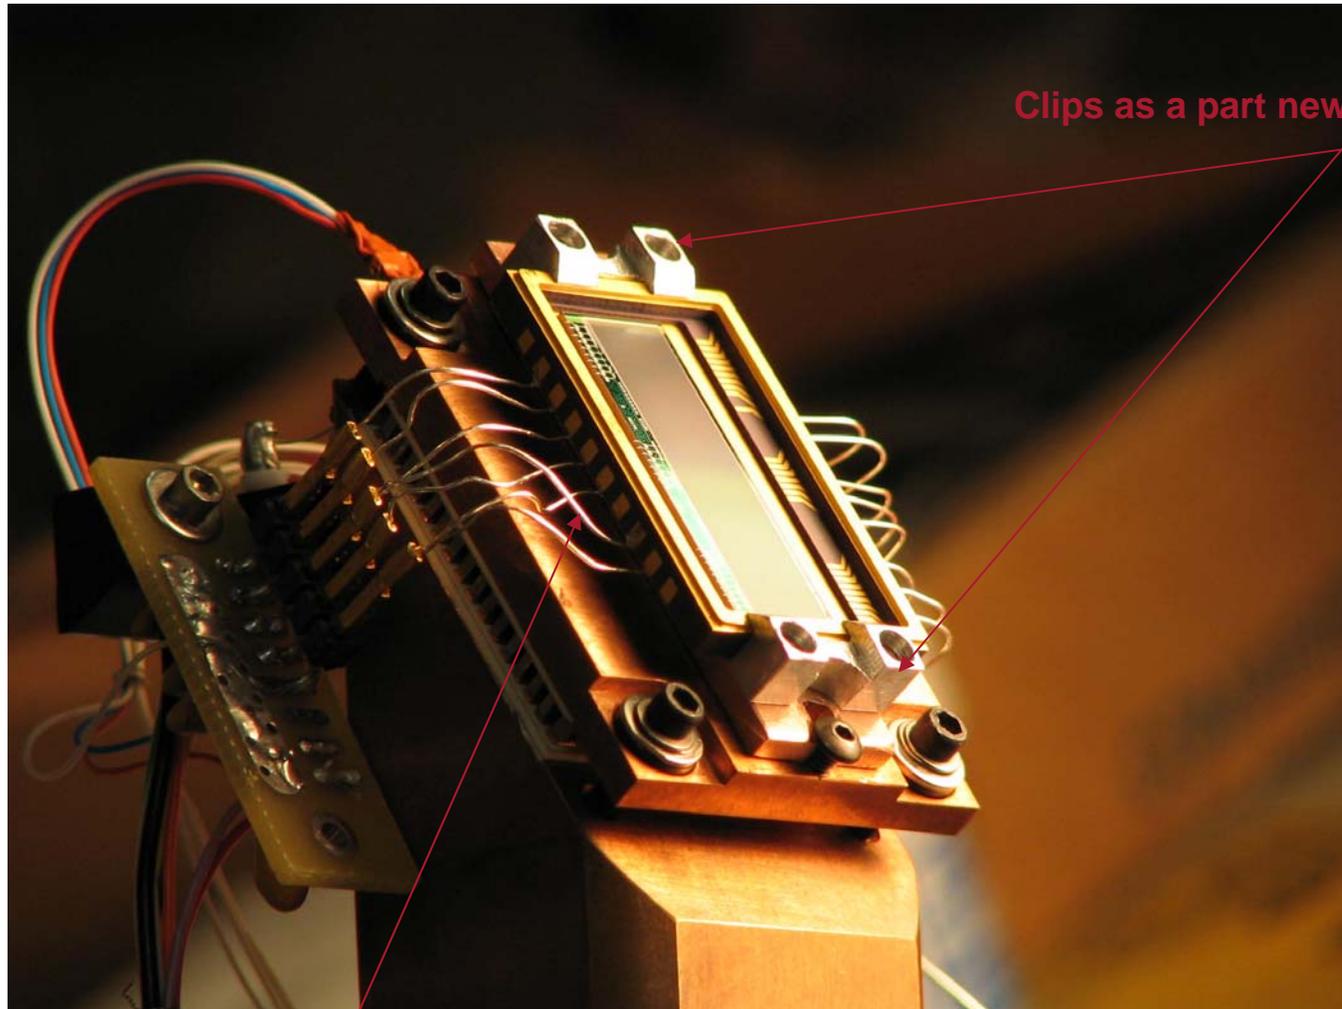
Instability in cleaned CCD

Significant responsivity change in 14 days with strong periodic wavelength dependence
